Verifying installation with storage arrays

ONTAP FlexArray

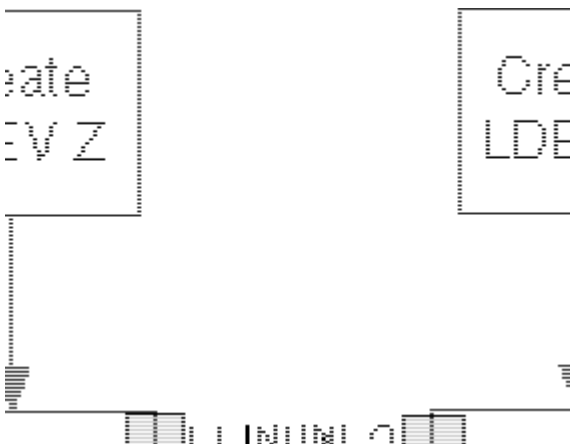
Assume that the storage array administrator creates a new LDEV Z. The LUN ID for LDEV Z is supposed to be LUN 3. However, the administrator presents LDEV Z as LUN 3 on storage array controller port 1A and as LUN 4 on storage array controller port 2A, as the following illustration shows:

To fix this problem, the same LUN ID must be assigned to an LDEV on all ports to which the LDEV is mapped.

In this example, the LDEV should be presented as LUN ID 3 on both ports.

Volume Set Addressing is inconsistent

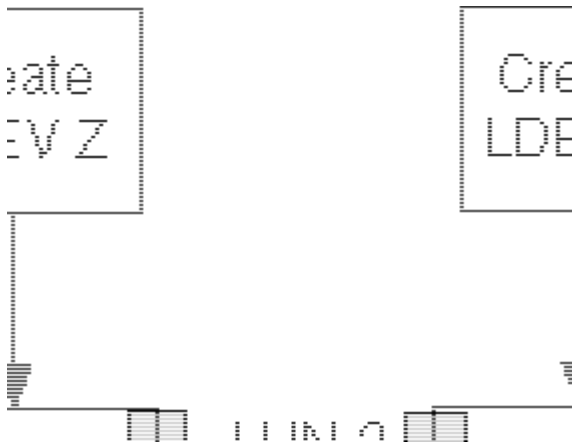
For this example of a mapping error, assume that the storage administrator created a new LDEV Z. The administrator mapped LDEV Z as LUN ID 3 to target port 1A. However, the administrator did not map the LDEV to target port 2A, as the following illustration shows. The result is only one path to the array LUN.

When this error is made, the `storage array config show` output shows only one path to the LUN, as the following example shows.

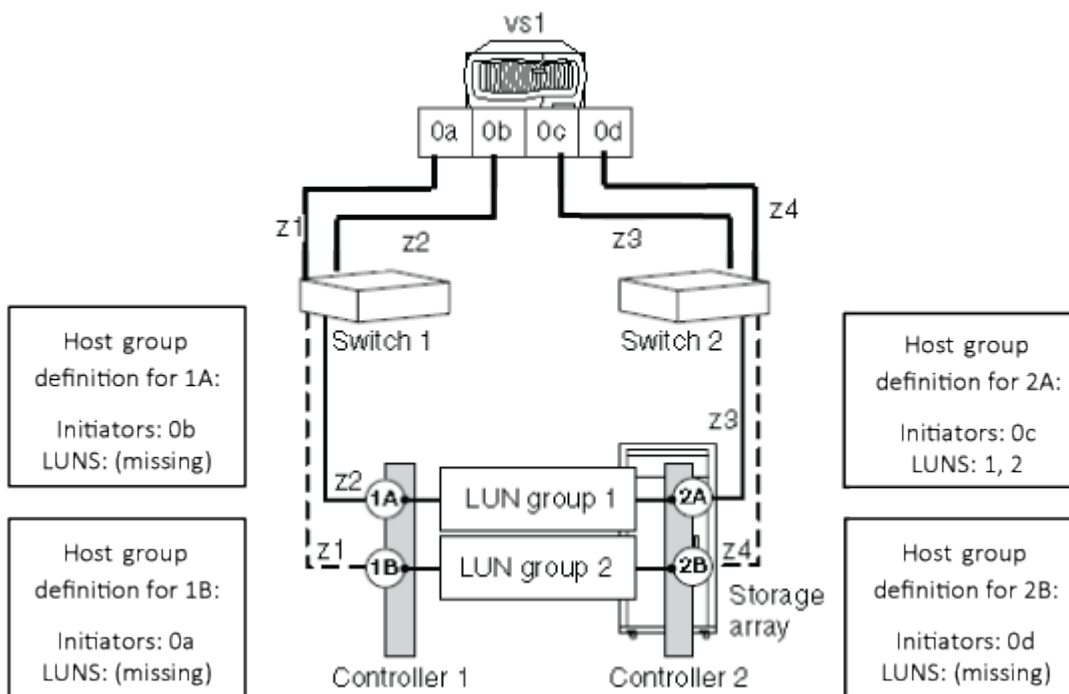
The open target port is caused by missing LUN IDs in the host group definition for storage controller 1A. In the host group definition for storage controller 1A, the FC initiator 0b is zoned into the target port and there is a host group defined for FC initiator port 0b, but there are no LUN IDs in the host group. As the illustration shows, the host group definition for storage controller 2A includes both initiators and LUNs.

The empty host group is caused by array LUNs not getting listed in the host group definition for storage controllers 1B and 2B. The FC initiators 0a and 0d are zoned into the target ports but no LUNs are shown.

The following example shows the `storage array config show` output for the illustrated situations where the ONTAP system is zoned to the storage array but there are no LUNs in the host group definitions for the storage controller 1A, resulting in an open target port. The controllers 1B and 2B do not have LUNs in their respective host group definitions, resulting in an empty host group.

In the output for the illustrated situations, the FC initiators 0a, 0b, and 0d show no LUNs in the LUN count field. For the FC initiator 0c, two LUNs are shown in LUN group1.

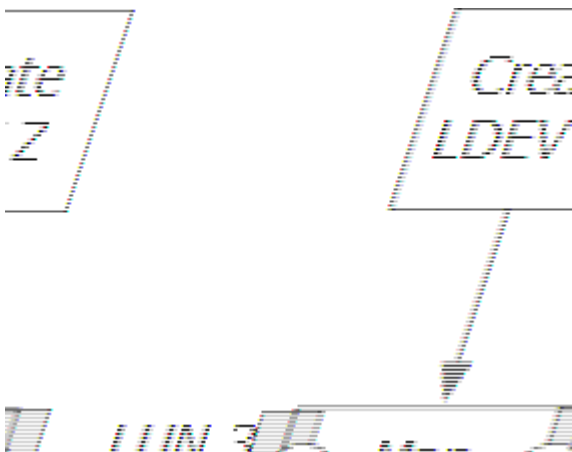
Assume that there are two existing LUN groups, LUN group 0 and LUN group 1. LUN group 0 has two array LUNs and LUN group 1 has three array LUNs. The administrator created a new LDEV Z, intending to add LUN 3 to LUN group 0. The administrator mapped LDEV Z as LUN 3 on two storage array ports. However, the ports to which LUN 3 are mapped, storage array ports 1A and 2B, are not a redundant target port pair, as the following illustration shows.

The result of this error is that a third, unintended LUN group is created (Group 2), as the following example shows:
