Duplicate LUN IDs on a target port

ONTAP FlexArray

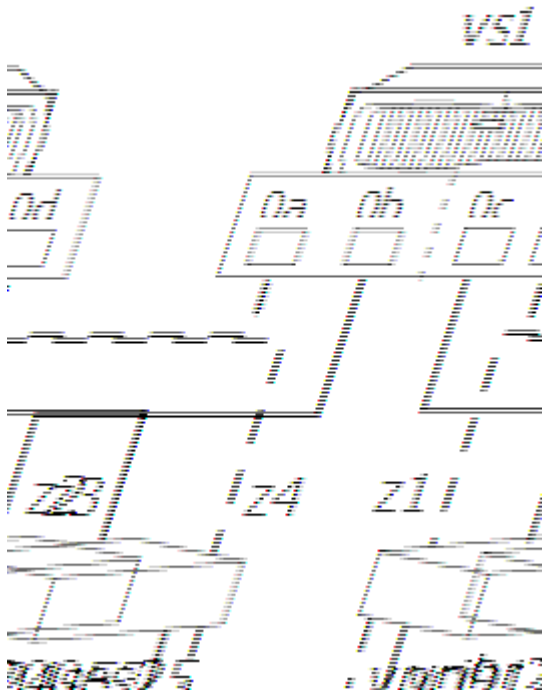
The following illustration shows the result of the zoning error:

As you can see from the illustration, two LUN groups are created. However, because of the zoning error, LUN group 0 and LUN group 1 are on the same target port pair (1A and 2A), instead of one LUN group being on each target port pair.

Zone	ONTAP system		Storage array	
Switch vnbr200es25				
z1	vs1	Port 0a	Controller 1	Port 1A
z2	vs1	Port 0b	Controller 1	Port 1A (instead of 1B)
Switch vnci9124s53				
z3	vs1	Port 0c	Controller 2	Port 2A
z4	vs1	Port 0d	Controller 2	Port 2A (instead of 2B)

The following storage array config show output for this example shows two LUN groups. The problem is that the two LUN groups have the same target ports.
