# Fewer than two paths to an array LUN

## ONTAP FlexArray

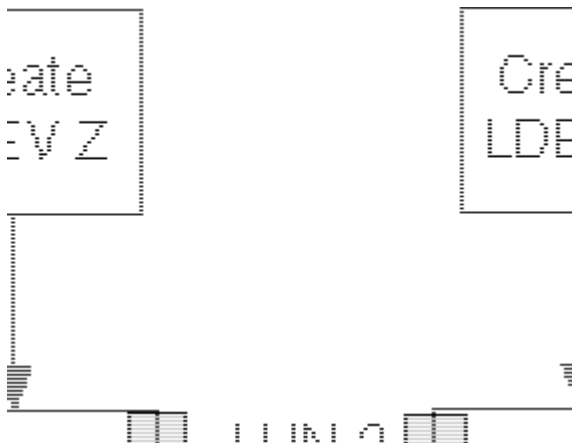
For this example of a mapping error, assume that the storage administrator created a new LDEV Z. The administrator mapped LDEV Z as LUN ID 3 to target port 1A. However, the administrator did not map the LDEV to target port 2A, as the following illustration shows. The result is only one path to the array LUN.

When this error is made, the storage array config show output shows only one path to the LUN, as the following example shows.
