Checking for back-end configuration errors preventing system operation

ONTAP FlexArray

NetApp
February 11, 2024

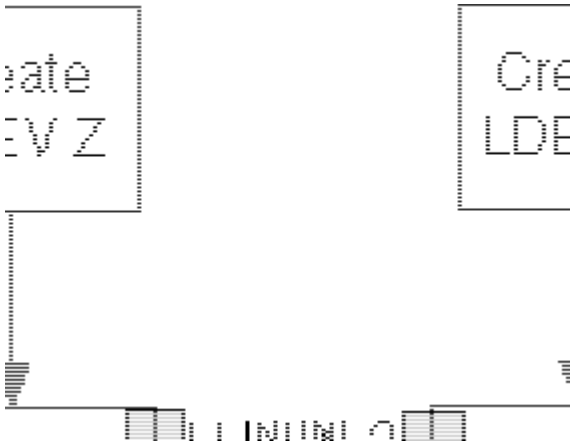
Assume that the storage array administrator creates a new LDEV Z. The LUN ID for LDEV Z is supposed to be LUN 3. However, the administrator presents LDEV Z as LUN 3 on storage array controller port 1A and as LUN 4 on storage array controller port 2A, as the following illustration shows:

To fix this problem, the same LUN ID must be assigned to an LDEV on all ports to which the LDEV is mapped. In this example, the LDEV should be presented as LUN ID 3 on both ports.

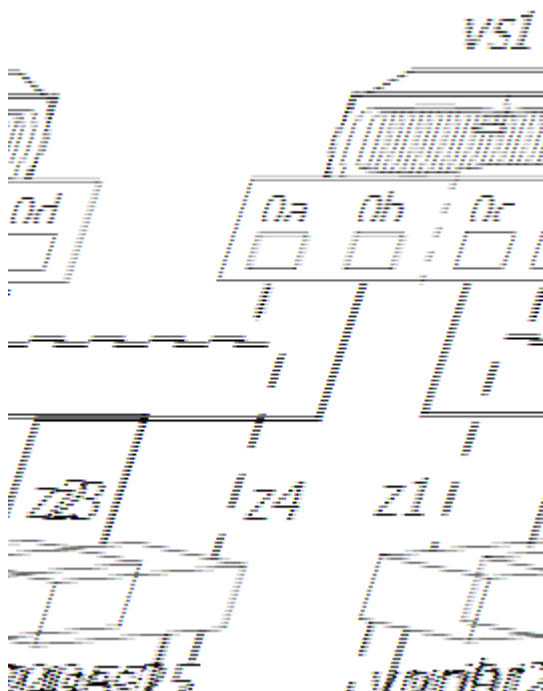
The following illustration shows the result of the zoning error:

As you can see from the illustration, two LUN groups are created. However, because of the zoning error, LUN group 0 and LUN group 1 are on the same target port pair (1A and 2A), instead of one LUN group being on each target port pair.

Zone	ONTAP system		Storage array	
z3	vs1	Port 0c	Controller 2	Port 2A
z4	vs1	Port 0d	Controller 2	Port 2A (instead of 2B)

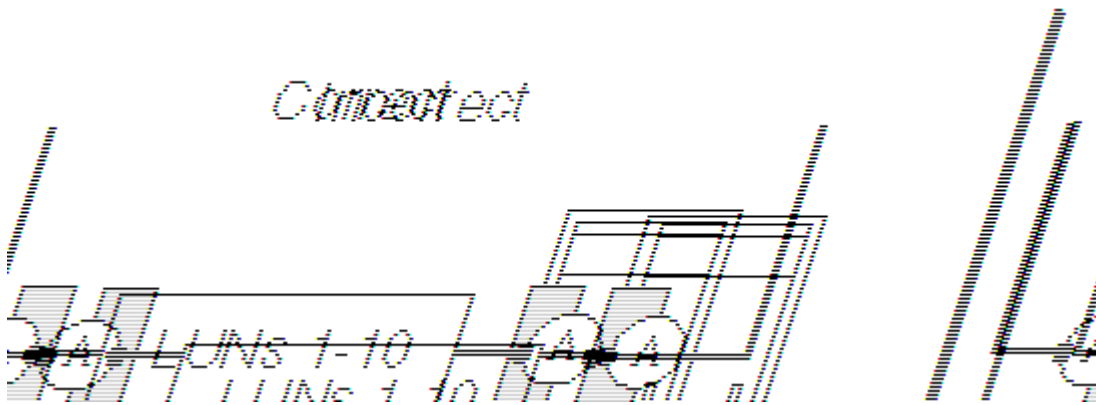
The following illustration shows correct and incorrect storage array port selection for setting up redundant paths to an array LUN so that you do not have a single fault domain. The path setup in the example on the left is correct because the paths to the array LUN are redundant—each connection is to a port on a different controller on the storage array. In the example on the right, both paths to the array LUN go to the same controller, which sets up a SPOF.

Using four paths to an array LUN, a storage array with FRUs with multiple directors (such as an EMC Symmetrix or HDS USP), or a storage array with dual controllers (such as an EMC CX, or HP EVA) are good methods for achieving redundancy. However, if you set up the paths to go through a single storage array controller or FRU, you are setting up your configuration with a SPOF, even with such features. On an active-active storage array, the entire FRU is considered to be one fault domain. An EMC Symmetrix storage array, for example, has multiple channel directors on the same FEBE board. A FEBE board is considered to be one fault domain because if all paths go through the same FEBE board, you lose all paths if you must replace the board.
