Checking for back-end configuration errors preventing system operation

ONTAP FlexArray

NetApp
September 20, 2021

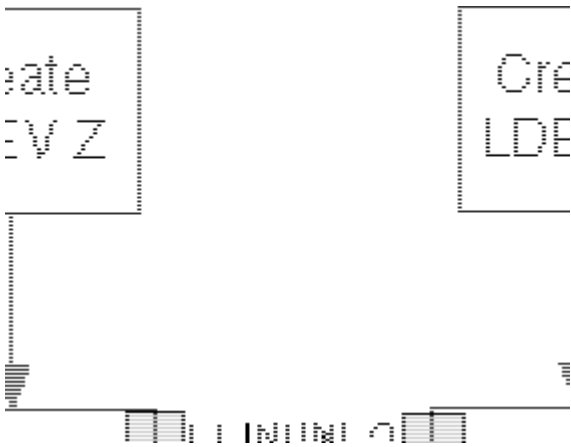
Assume that the storage array administrator creates a new LDEV Z. The LUN ID for LDEV Z is supposed to be LUN 3. However, the administrator presents LDEV Z as LUN 3 on storage array controller port 1A and as LUN 4 on storage array controller port 2A, as the following illustration shows:

To fix this problem, the same LUN ID must be assigned to an LDEV on all ports to which the LDEV is mapped. In this example, the LDEV should be presented as LUN ID 3 on both ports.

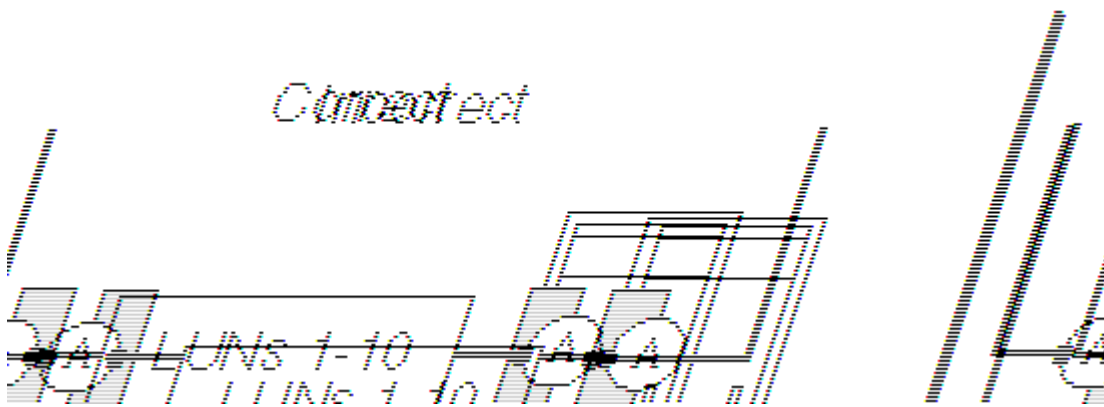
The following illustration shows correct and incorrect storage array port selection for setting up redundant paths to an array LUN so that you do not have a single fault domain. The path setup in the example on the left is correct because the paths to the array LUN are redundant—each connection is to a port on a different controller on the storage array. In the example on the right, both paths to the array LUN go to the same controller, which sets up a SPOF.

Using four paths to an array LUN, a storage array with FRUs with multiple directors (such as an EMC Symmetrix or HDS USP), or a storage array with dual controllers (such as an EMC CX, or HP EVA) are good methods for achieving redundancy. However, if you set up the paths to go through a single storage array controller or FRU, you are setting up your configuration with a SPOF, even with such features. On an active-active storage array, the entire FRU is considered to be one fault domain. An EMC Symmetrix storage array, for example, has multiple channel directors on the same FEBE board. A FEBE board is considered to be one fault domain because if all paths go through the same FEBE board, you lose all paths if you must replace the board.
