# Troubleshooting configurations with storage arrays

ONTAP FlexArray

NetApp  
September 20, 2021

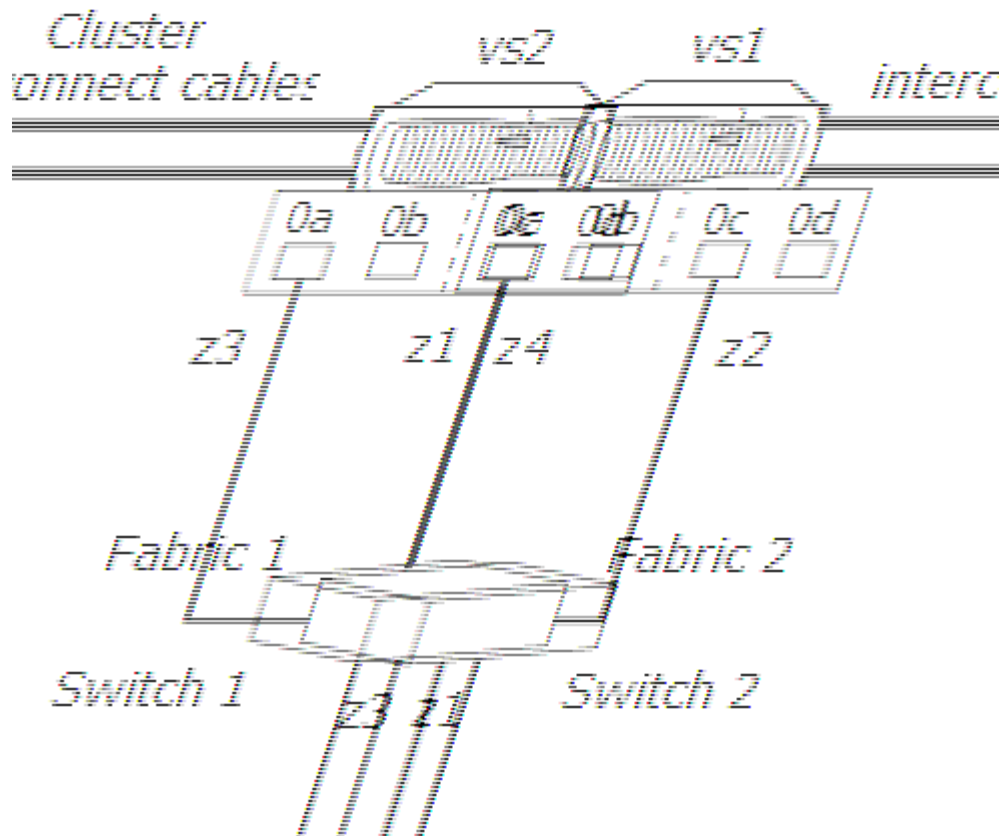
The following configuration is invalid because it does not provide alternate paths from each FC initiator port on the ONTAP systems to each LUN on the storage array. Both FC initiator ports from the same ONTAP system are connected to the storage array through the same switch.

Assume that the following zoning is in place in this invalid example:

- For *vs1*:
  - *0a* is zoned to see Controller 1 Port A.
  - *0c* is zoned to see Controller 1 Port B.
- For *vs2*:
  - *0a* is zoned to see Controller 2 Port A.
  - *0c* is zoned to see Controller 2 Port B.
