# **Troubleshooting configurations with storage arrays**

ONTAP FlexArray

NetApp  
February 11, 2024

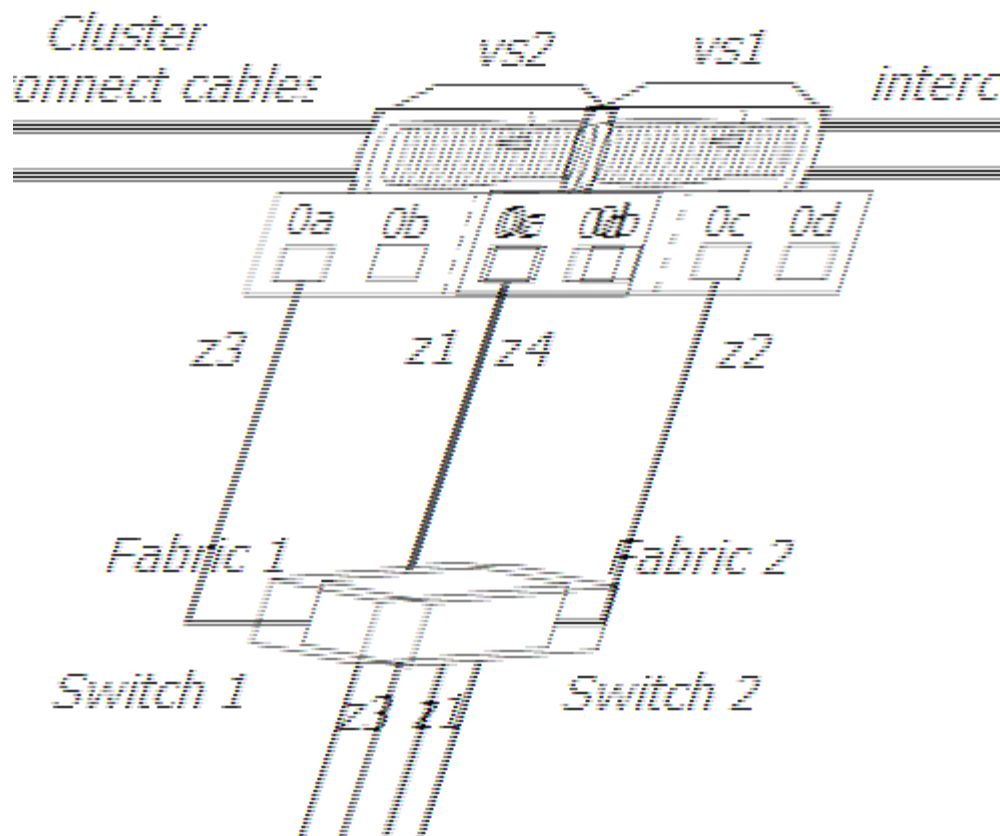
The following configuration is invalid because it does not provide alternate paths from each FC initiator port on the ONTAP systems to each LUN on the storage array. Both FC initiator ports from the same ONTAP system are connected to the storage array through the same switch.

It is important to set up alternate paths to all array LUNs from both FC initiators on the ONTAP system, thereby avoiding a single point of failure (SPOF).

Assume that the following zoning is in place in this invalid example:

- For vs1:
  - 0a is zoned to see Controller 1 Port A.
  - 0c is zoned to see Controller 1 Port B.
- For vs2:
  - 0a is zoned to see Controller 2 Port A.
  - 0c is zoned to see Controller 2 Port B.
