# Verifying installation with storage arrays

## ONTAP FlexArray

NetApp  
September 20, 2021

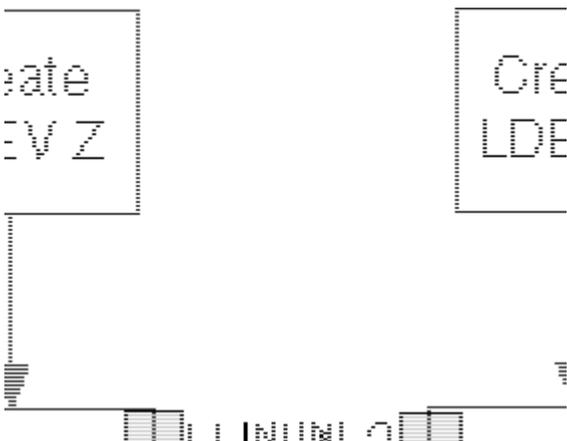
Assume that the storage array administrator creates a new LDEV Z. The LUN ID for LDEV Z is supposed to be LUN 3. However, the administrator presents LDEV Z as LUN 3 on storage array controller port 1A and as LUN 4 on storage array controller port 2A, as the following illustration shows:

To fix this problem, the same LUN ID must be assigned to an LDEV on all ports to which the LDEV is mapped.

In this example, the LDEV should be presented as LUN ID 3 on both ports.

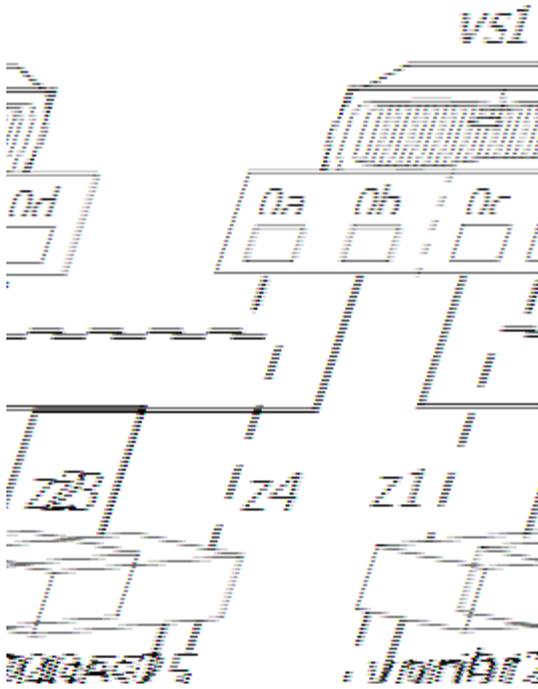
The following illustration shows the result of the zoning error:

As you can see from the illustration, two LUN groups are created. However, because of the zoning error, LUN group 0 and LUN group 1 are on the same target port pair (1A and 2A), instead of one LUN group being on each target port pair.

Zone	ONTAP system		Storage array	
Switch vnbr200es25				
z1	vs1	Port 0a	Controller 1	Port 1A
z2	vs1	Port 0b	Controller 1	Port 1A (instead of 1B)
Switch vnci9124s53				
z3	vs1	Port 0c	Controller 2	Port 2A
z4	vs1	Port 0d	Controller 2	Port 2A (instead of 2B)

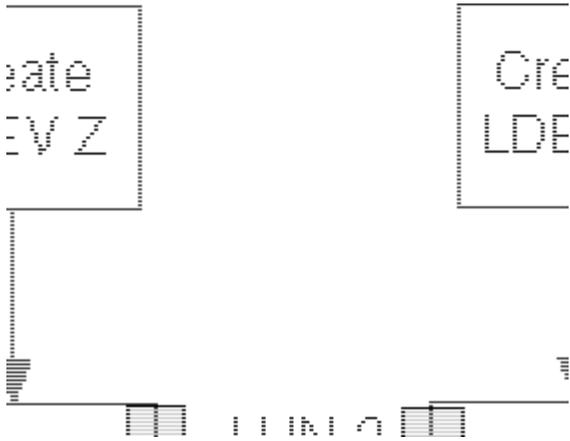
For this example of a mapping error, assume that the storage administrator created a new LDEV Z. The administrator mapped LDEV Z as LUN ID 3 to target port 1A. However, the administrator did not map the LDEV to target port 2A, as the following illustration shows. The result is only one path to the array LUN.

When this error is made, the storage array config show output shows only one path to the LUN, as the following example shows.

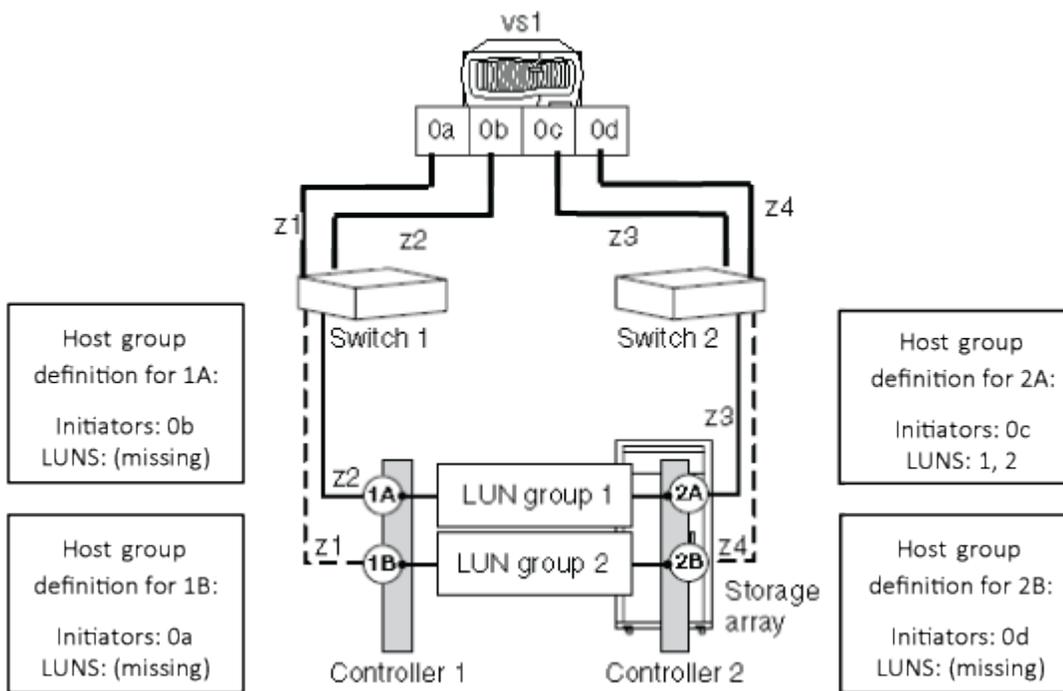
The open target port is caused by missing LUN IDs in the host group definition for storage controller 1A. In the host group definition for storage controller 1A, the FC initiator 0b is zoned into the target port and there is a host group defined for FC initiator port 0b, but there are no LUN IDs in the host group. As the illustration shows, the host group definition for storage controller 2A includes both initiators and LUNs.

The empty host group is caused by array LUNs not getting listed in the host group definition for storage controllers 1B and 2B. The FC initiators 0a and 0d are zoned into the target ports but no LUNs are shown.

The following example shows the `storage array config show` output for the illustrated situations where the ONTAP system is zoned to the storage array but there are no LUNs in the host group definitions for the storage controller 1A, resulting in an open target port. The controllers 1B and 2B do not have LUNs in their respective host group definitions, resulting in an empty host group.

In the output for the illustrated situations, the FC initiators 0a, 0b, and 0d show no LUNs in the LUN count field. For the FC initiator 0c, two LUNs are shown in LUN group1.

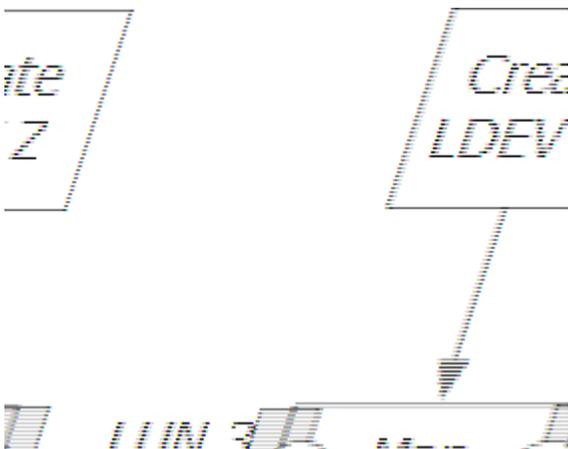
Assume that there are two existing LUN groups, LUN group 0 and LUN group 1. LUN group 0 has two array LUNs and LUN group 1 has three array LUNs. The administrator created a new LDEV Z, intending to add LUN 3 to LUN group 0. The administrator mapped LDEV Z as LUN 3 on two storage array ports. However, the ports to which LUN 3 are mapped, storage array ports 1A and 2B, are not a redundant target port pair, as the following illustration shows.

The result of this error is that a third, unintended LUN group is created (Group 2), as the following example shows:
