Verifying that the back-end configuration matches the intended configuration

ONTAP FlexArray

NetApp
February 11, 2024

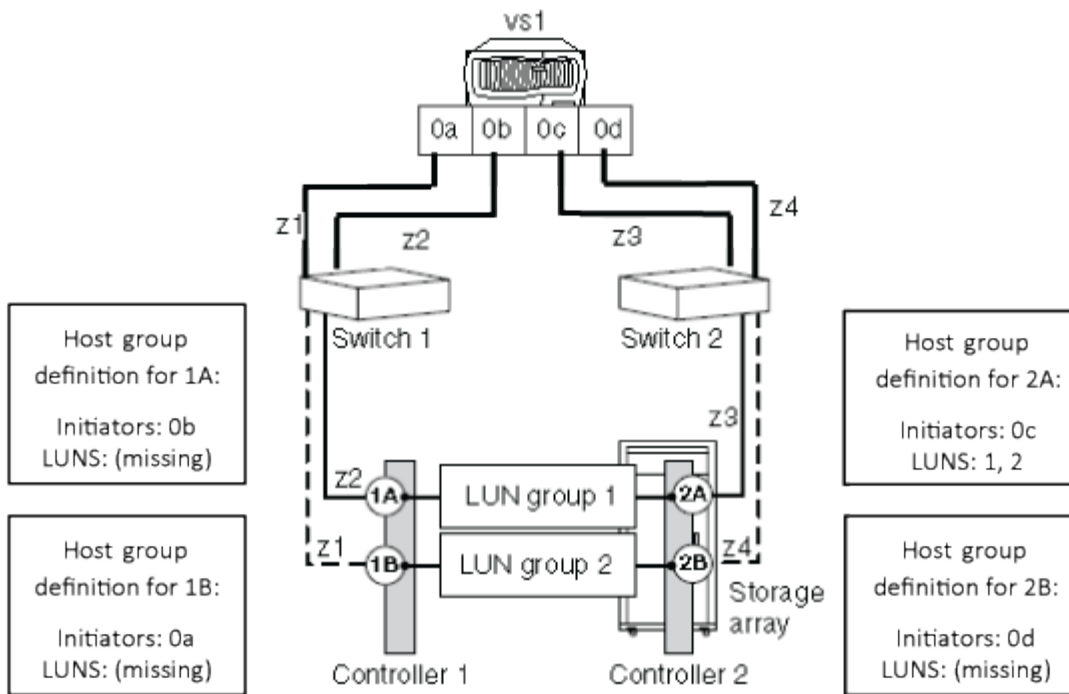
The open target port is caused by missing LUN IDs in the host group definition for storage controller 1A. In the host group definition for storage controller 1A, the FC initiator 0b is zoned into the target port and there is a host group defined for FC initiator port 0b, but there are no LUN IDs in the host group. As the illustration shows, the host group definition for storage controller 2A includes both initiators and LUNs.

The empty host group is caused by array LUNs not getting listed in the host group definition for storage controllers 1B and 2B. The FC initiators 0a and 0d are zoned into the target ports but no LUNs are shown.

The following example shows the `storage array config show` output for the illustrated situations where the ONTAP system is zoned to the storage array but there are no LUNs in the host group definitions for the storage controller 1A, resulting in an open target port. The controllers 1B and 2B do not have LUNs in their respective host group definitions, resulting in an empty host group.

In the output for the illustrated situations, the FC initiators 0a, 0b, and 0d show no LUNs in the LUN count field. For the FC initiator 0c, two LUNs are shown in LUN group1.
