Verifying that the back-end configuration matches the intended configuration

ONTAP FlexArray

NetApp
September 20, 2021

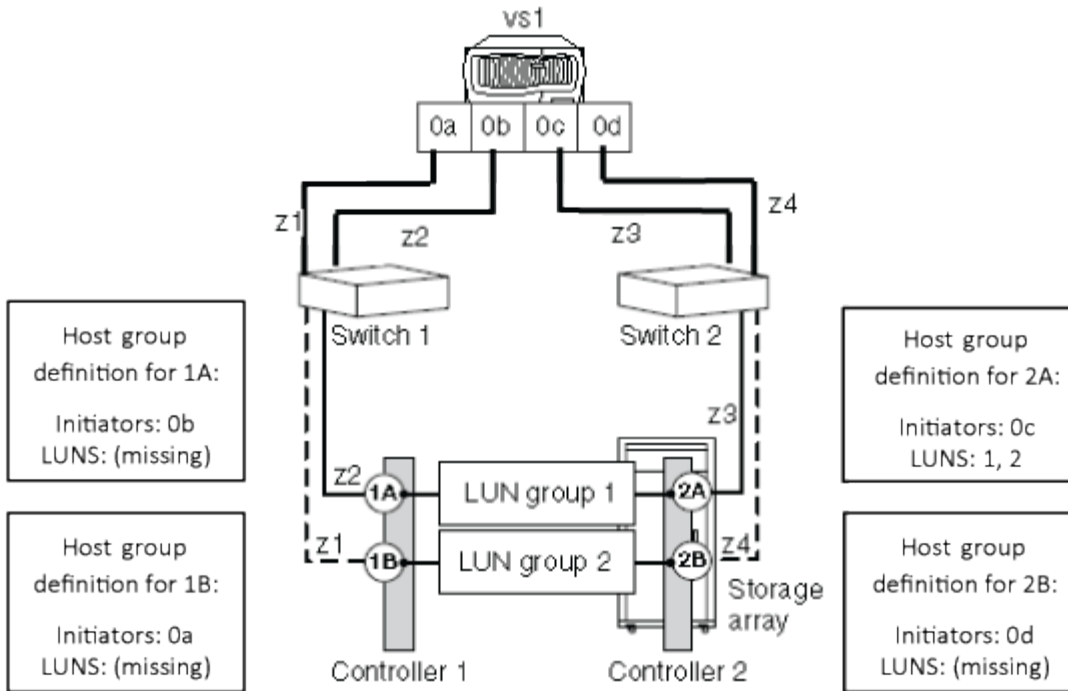
The open target port is caused by missing LUN IDs in the host group definition for storage controller 1A. In the host group definition for storage controller 1A, the FC initiator 0b is zoned into the target port and there is a host group defined for FC initiator port 0b, but there are no LUN IDs in the host group. As the illustration shows, the host group definition for storage controller 2A includes both initiators and LUNs.

The empty host group is caused by array LUNs not getting listed in the host group definition for storage controllers 1B and 2B. The FC initiators 0a and 0d are zoned into the target ports but no LUNs are shown.

The following example shows the `storage array config show` output for the illustrated situations where the ONTAP system is zoned to the storage array but there are no LUNs in the host group definitions for the storage controller 1A, resulting in an open target port. The controllers 1B and 2B do not have LUNs in their respective host group definitions, resulting in an empty host group.

In the output for the illustrated situations, the FC initiators 0a, 0b, and 0d show no LUNs in the LUN count field. For the FC initiator 0c, two LUNs are shown in LUN group1.
