I/O misalignments might occur on properly aligned LUNs

ONTAP 9

NetApp
November 24, 2021

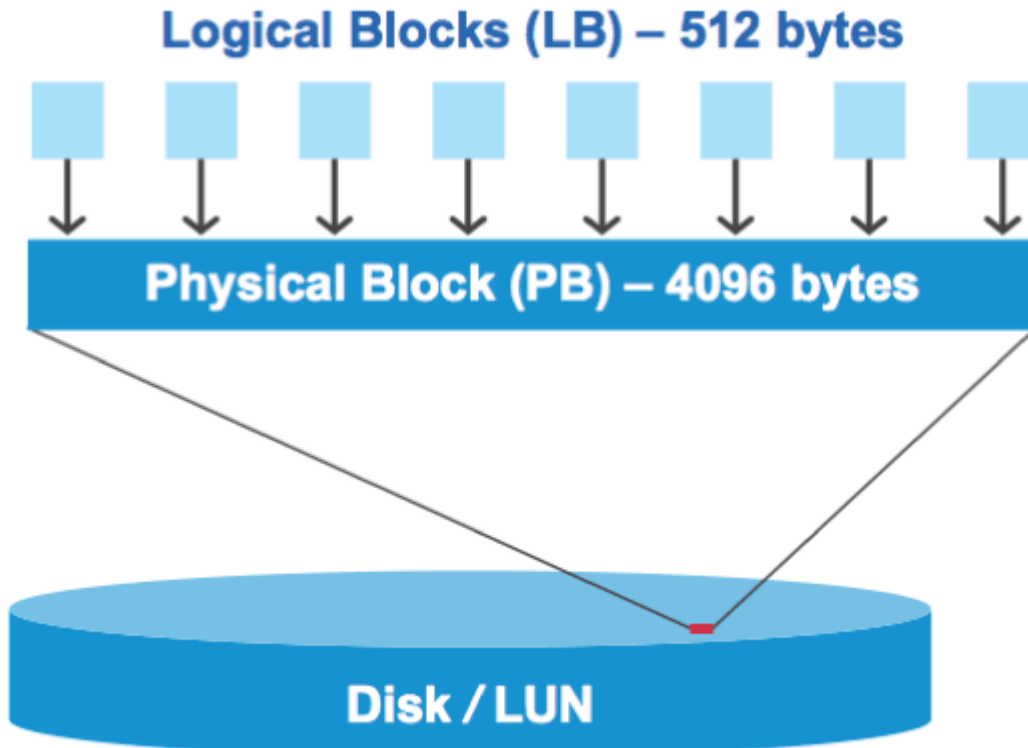
LUNs and hard disks both provide storage as blocks. Because the block size for disks on the host is 512 bytes, LUNs present blocks of that size to the host while actually using larger, 4-KB blocks to store data. The 512-byte data block used by the host is referred to as a logical block. The 4-KB data block used by the LUN to store data is referred to as a physical block. This means that there are eight 512-byte logical blocks in each 4-KB physical block.

The host operating system can begin a read or write I/O operation at any logical block. I/O operations are only considered aligned when they begin at the first logical block in the physical block. If an I/O operation begins at a logical block that is not also the start of a physical block, the I/O is considered misaligned. ONTAP automatically detects the misalignment and reports it on the LUN. However, the presence of misaligned I/O does not necessarily mean that the LUN is also misaligned. It is possible for misaligned I/O to be reported on properly aligned LUNs.
